DEPARTMENT OF TRANSPORTATION**DIVISION OF ENGINEERING SERVICES**

Quality Assurance and Source Inspection

Contract #: 04-0120F4Cty: SF/ALA Rte: 80 PM: 13.2/13.9File #: 1x.28**WELDING INSPECTION REPORT****Resident Engineer:**Pursell, Gary**Address:** 333 Burma Road**City:** Oakland, CA 94607**Report No:** WIR-012989**Date Inspected:** 13-Apr-2010**Project Name:** SAS Superstructure**OSM Arrival Time:** 1100**Prime Contractor:** American Bridge/Fluor Enterprises, a JV**OSM Departure Time:** 1930**Contractor:** American Bridge/Fluor Enterprises, a JV**Location:** Job Site

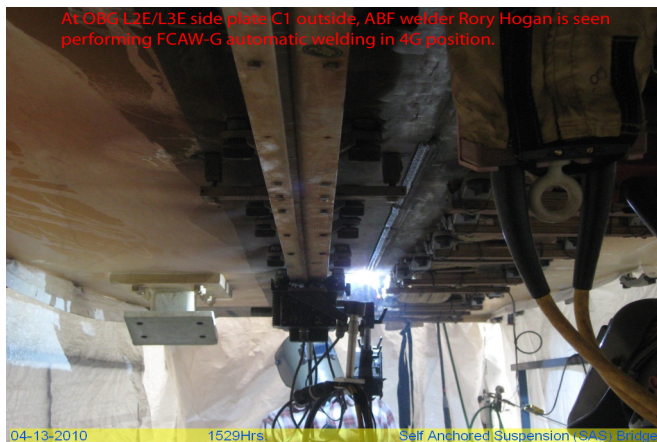
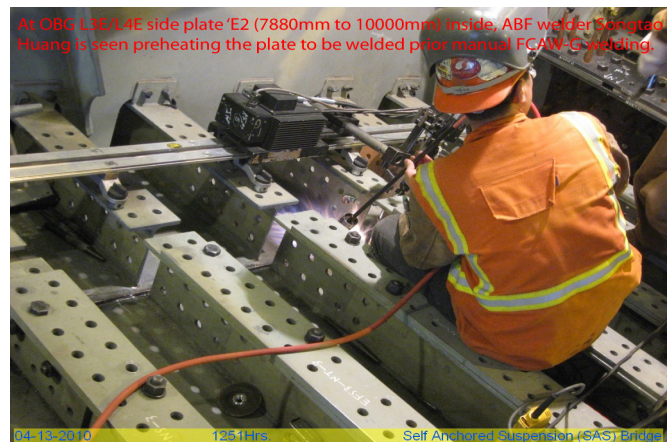
During the work shift, QA observed that the ABF welding personnel failed to maintain the minimum required preheat of 93.3°C (200°F) after welding had been started. It was noted that on one side of the weld where the heater blanket is located the preheat temperature of the plate was noted greater than 200 degree Fahrenheit whereas the other side of the weld wherein there is no heater blanket the preheat temperature was 134 to 150 degree Fahrenheit.

After the welders were informed about the insufficient preheat, they immediately moved the heater blanket on top of the weld and waited until the preheat went back to >200 degree Fahrenheit before they resume welding. QA had informed ABF QC Jim Cunningham about the drop of temperature in preheat maintenance during the grinding/cleaning of weld pass by the welders. QA also informed ABF QC that due to this incident an incident report will be issued.
